**MELKRIDGE HOUSE,
95 GILESGATE, DURHAM.**

**AN ARCHAEOLOGICAL WATCHING
BRIEF DURING EXCAVATIONS FOR
FOUNDATIONS OF A NEW GARAGE**

**ARCHAEO-ENVIRONMENT LTD
For Gwendolynn Heley.**

AE Report No. AE-0066/09

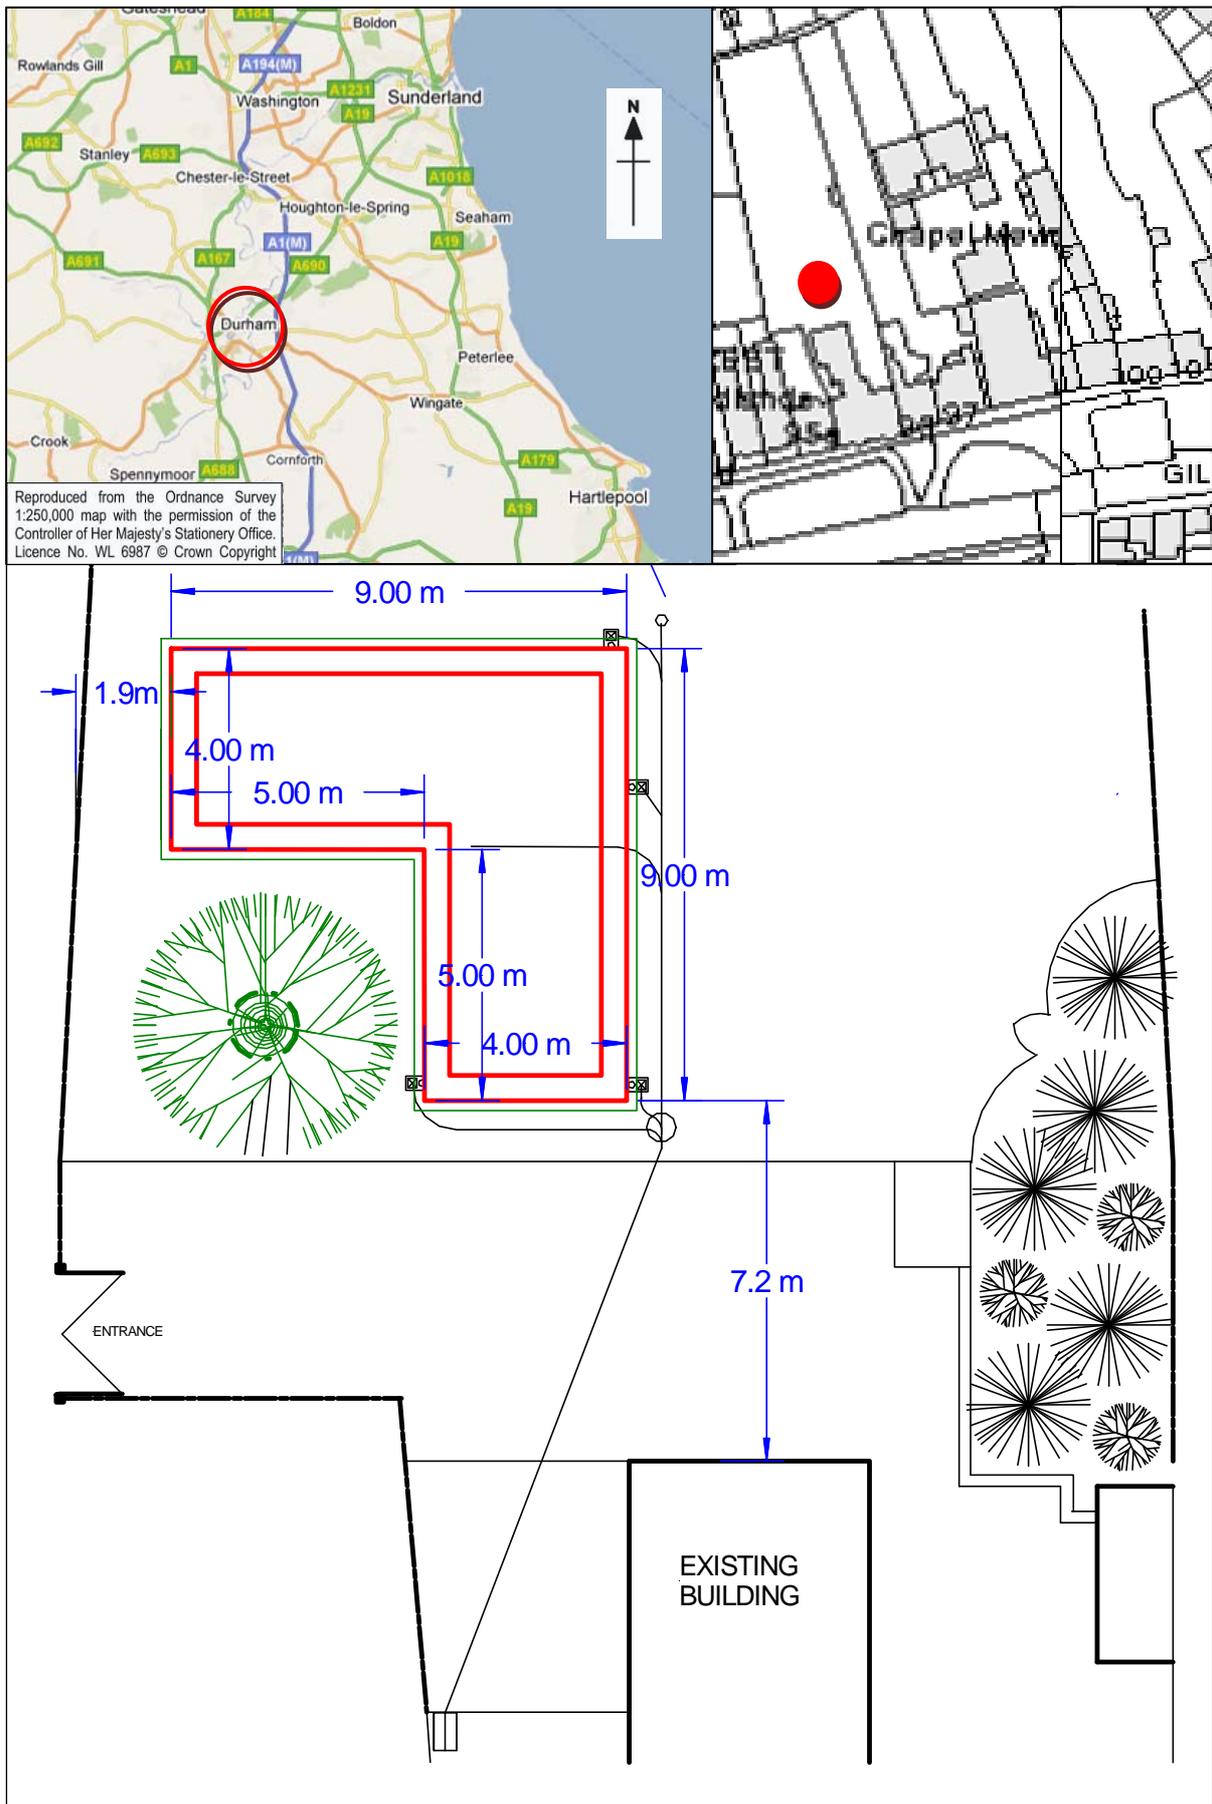
Figure 1. Melkridge House, 95 Gilesgate, Durham City. Location and plan of area of excavation.

Gilesgate is an historic suburb of Durham City and situated approximately 1 Km to the east of the Peninsula. Melkridge House sits on the north side of the settlement and the development was located at NZ (4)2848 (5)4279 (Figure 1).

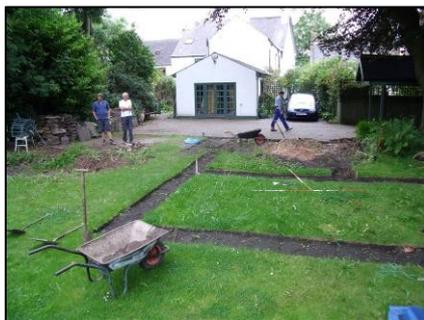
Figure 2. Area prior to excavation looking south to Melkridge House.

- 1.3 AE attended site on the 26th of June 2009, the turf outline of the trenches had been removed with agreement prior to the arrival of the archaeologist on site (figure 2). Excavation of the foundation trenches began once the archaeologist was on site.

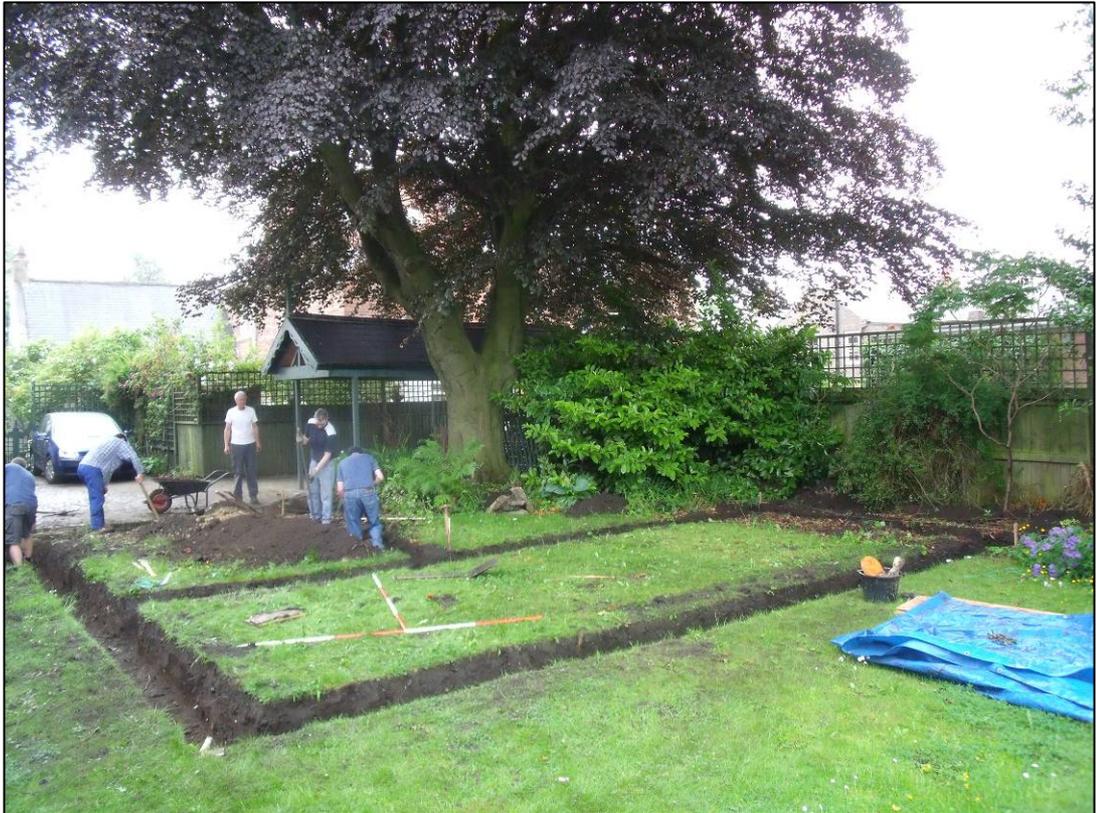
Figure 3. Completed excavation of foundations.

- 5.1 Archaeological observation was undertaken over a single day on June 26th 2009, when all necessary excavation was completed. On the following day it is understood that mini-piles and foundations were laid, this was not monitored by the archaeologist.
- 5.2 A number of linear trenches were hand excavated marking the perimeter of the new building and internal structural elements as shown in figure 1. The trenches were approximately 400mm in width, and between 400mm and 500mm in depth. An extension of the trench ran to the south-west to connect up with existing services (figure 4).

- 5.3 [001] Within the footprint of the new building, the immediate layer of turf and top soil was observed to be a maximum of 150mm deep. This was composed of a moderately compact silt/sand/clay matrix (30/30/40%), with moderate inclusions of small fragments of buff stone and occasional fragments of glass, burnt shale, glazed and un-glazed pottery. This was clearly a garden soil and contained no structures.
- 5.4 [002] Beneath the topsoil [001], there was a further layer of soil and composed of similar material; silt/sand/clay (30/40/30%) and of a uniform depth of 120mm when

seen in section. This layer was more compact than [001] and contained frequent inclusions of coal, ceramic building material and stone.

- 5.5 [003] Beneath the subsoil [002], this layer was very compact and composed of coarse sand/fine sand/Clay (50/10/40%). It included frequent inclusions of coal fragments and flecks up to 80mm in diameter.
- 5.6 [004] This context formed the upper levels of the service trench and represented modern brick sets over a crushed dolomite aggregate sub base. This was very compact and a maximum of 170mm in depth, beneath which was context [002].

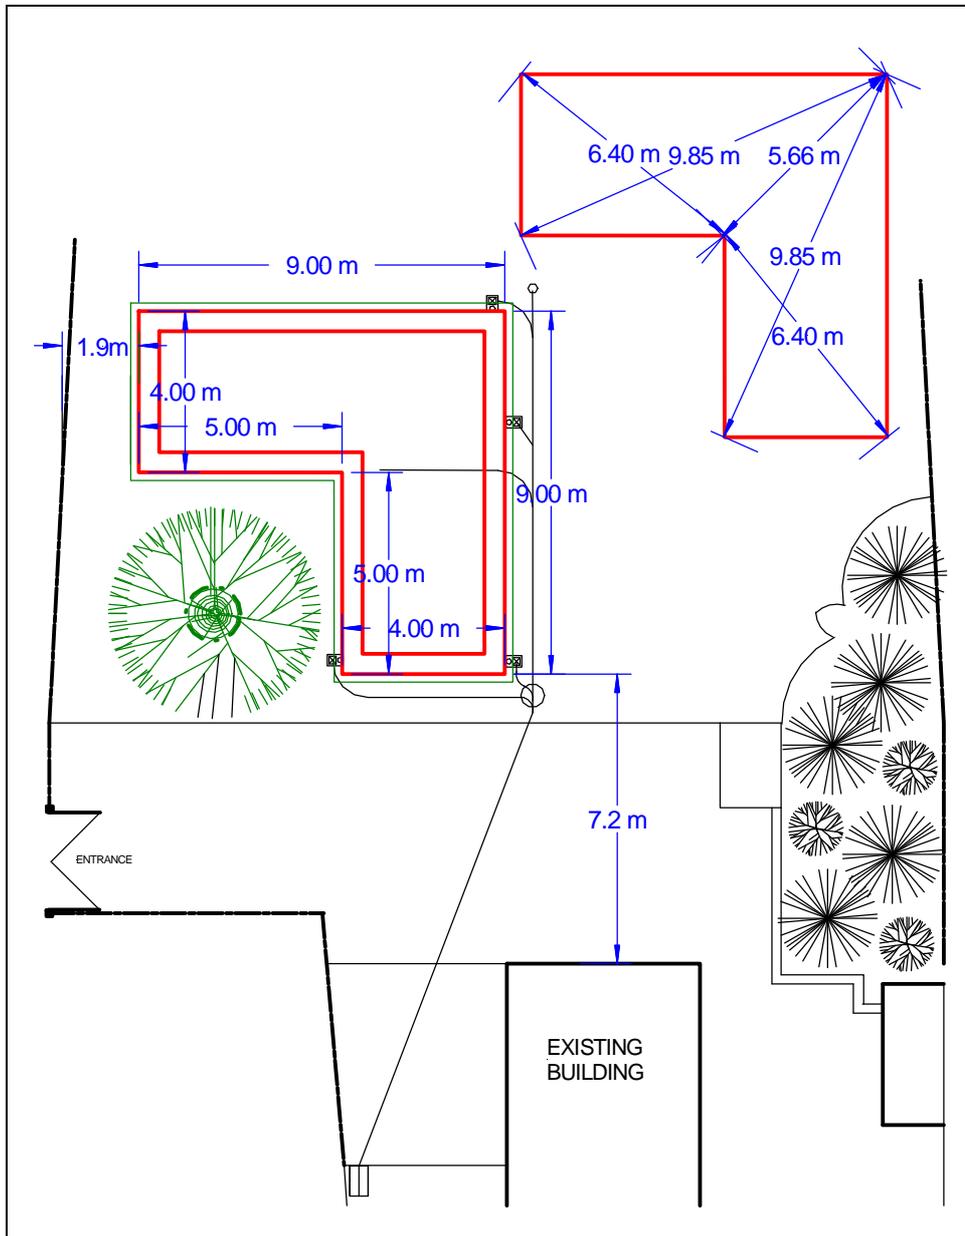
Figure 1: showing plan of intended foundation and service trenches.

- 1.3 Planning permission has been granted by Durham City Council for the construction of the garage on the condition that an archaeological watching brief is carried out during all groundworks. These will comprise the hand excavation of shallow strip foundations (shown on Figure 1), measuring 0.50m wide, down to a depth of 0.60m below the present ground surface. A total of 17 minipiles will then be driven down to stable clay (estimated to be approximately 1m below current ground surface), or bedrock (estimated to be 5m below current ground surface), depending on the stability of the underlying material.

- 1.4 In addition to the foundations, a single service trench will be excavated as shown on the accompanying plan (Figure 1). This will be 0.60m wide and extend no more than 0.60m below the current ground surface; although this may be increased by an estimated 0.30m if obstacles are encountered. All three services – drainage, water and electrics – will be laid in the same trench. The trench will be excavated predominantly through made-ground laid down when the existing paved area was constructed. All services will link in with existing drainage chambers.
